## **Kinetic Super-Resolution Long-Wave Infrared (KSR LWIR) Thermography Diagnostic for Building Envelopes**

Camp Lejeune, NC

August 2015

Final Report

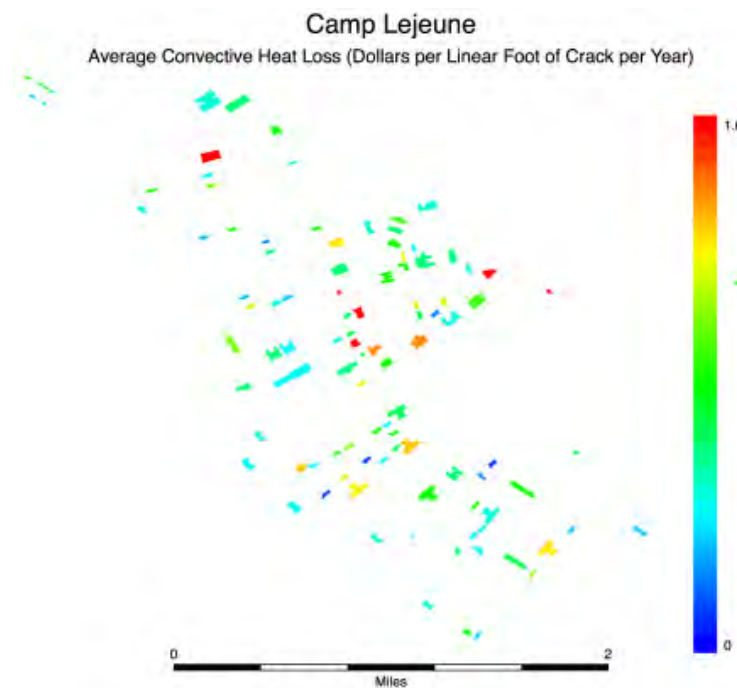
Figure 4-11. Average convective heat loss for Camp Lejeune, NC.

The convective heat loss map shown in Figure 4-11 represents the average dollar loss per square foot from convective leaks, e.g., leaks of energy through infiltration via cracks and gaps in door and window frames. Buildings highlighted in red are the most emissive, with the highest annual additional heating and cooling load per square foot.

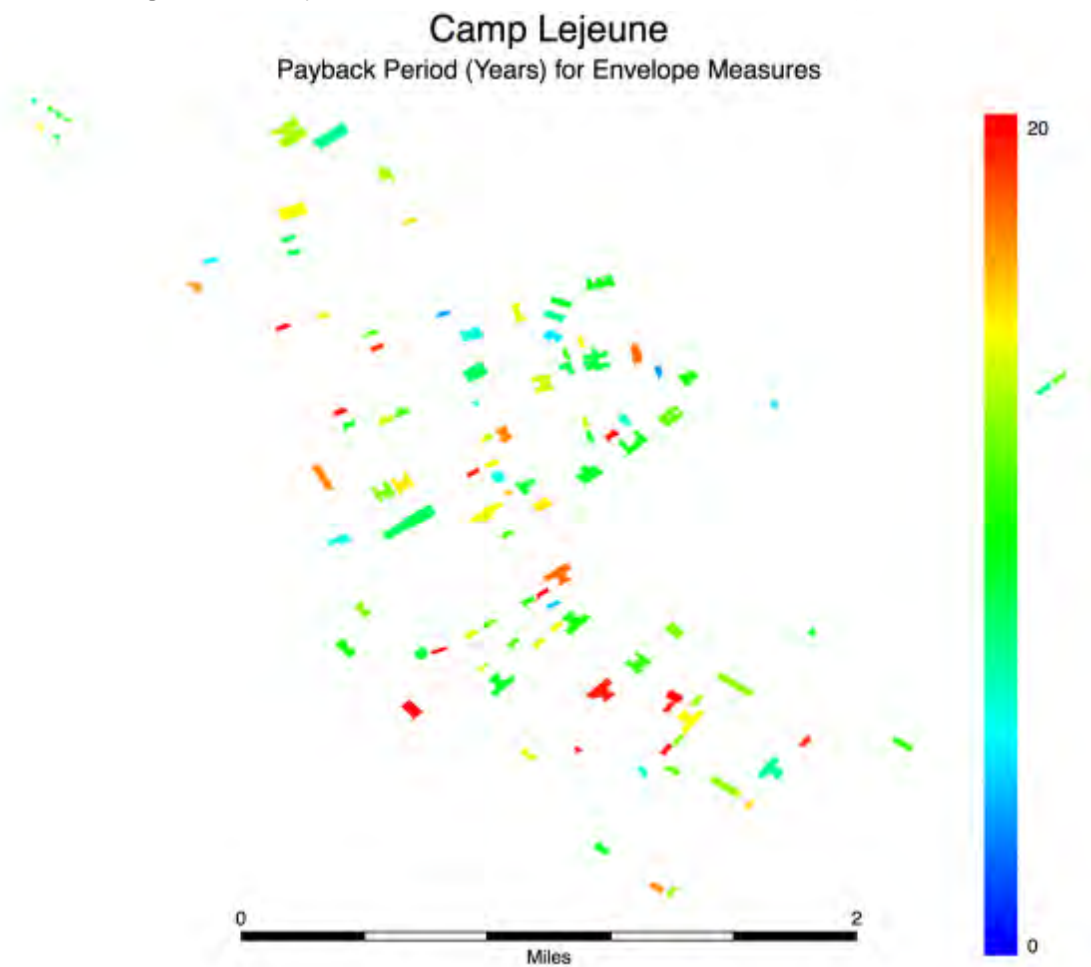
Figure 4-12. Payback period for envelope measures for Camp Lejeune, NC.

The above payback period map (Figure 4-12) shows the combined cost effectiveness of the remediation of conductive and convective leaks expressed as a payback period (in years). Buildings in blue have an attractive payback period, while buildings in red have a less attractive payback period.

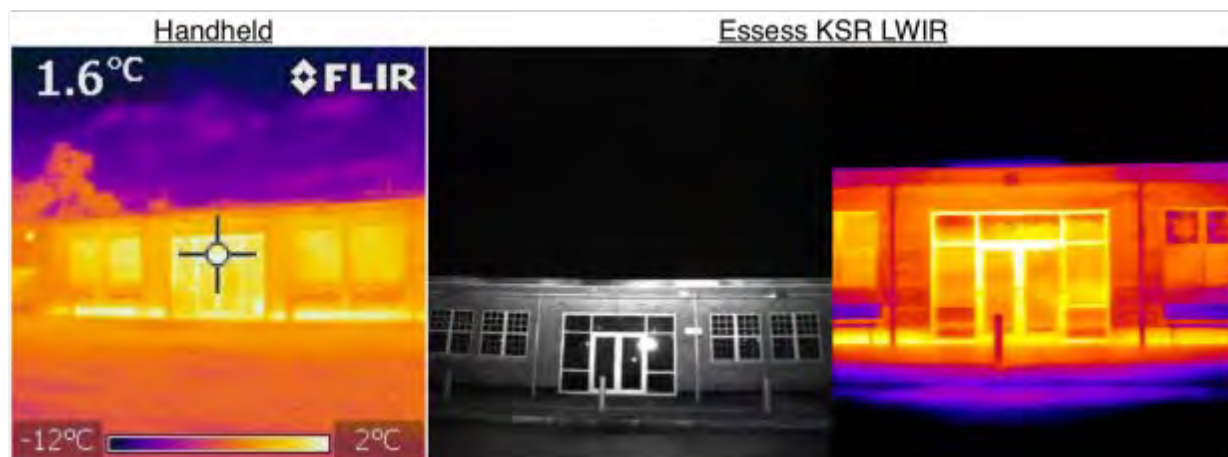
Figure 5-1. Handheld thermographic image versus Essess KSR LWIR thermographic image for Bldg 235, Camp Lejeune, NC.

The resolution and FOV of the handheld unit is not nearly as good as the cameras employed in the vehicle scanning system (Figure 5-1). The resolution is 15 times higher in the cameras used on the Essess scanning system. The FOV of the scanning system is higher. Due to multiple overlapping features and high acquisition speed, the effective FOV is exceedingly high.

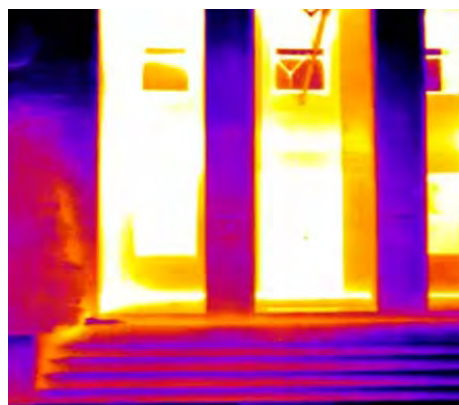
Figure 5-5. Thermal image of Bldg 1, Camp Lejeune.

Bldg 1 (Figures 5-4 and 5-5) has an electricity usage of 21.5 kWh per square foot per year.

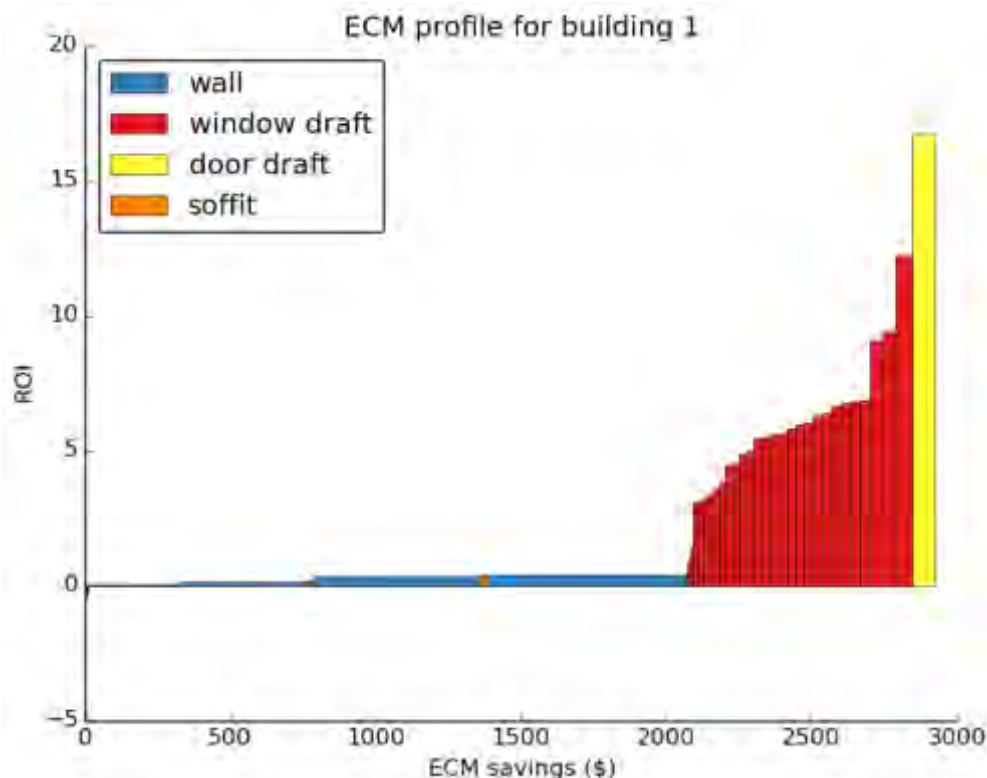
Figure 5-6. ECM savings for Bldg 1, Camp Lejeune, NC.

Figure 5-6 shows an abatement curve for all identified remediation measures for the building in question. Each bar represents a distinct remediation. The width of the bars represents the savings potential, while the height represents the economic viability (represented by ROI). The height of each bar shows how many dollars of savings may be expected for every \$1 spent on the remediation measure.

Table 5-1. Envelope ECMs, Bldg 1, Camp Lejeune.

ECM Name	kWh Saved	Therms Saved	Dollars Saved	Upfront Cost	Payback Period
Improve Wall Insulation	3161	3096	2003	24240	12.1
Seal Window Frame Leaks	1244	1218	788	2069	2.6
Seal Door Frame Leaks	120	118	76	65	0.8
Improve Soffit Insulation	79	77	50	583	11.7

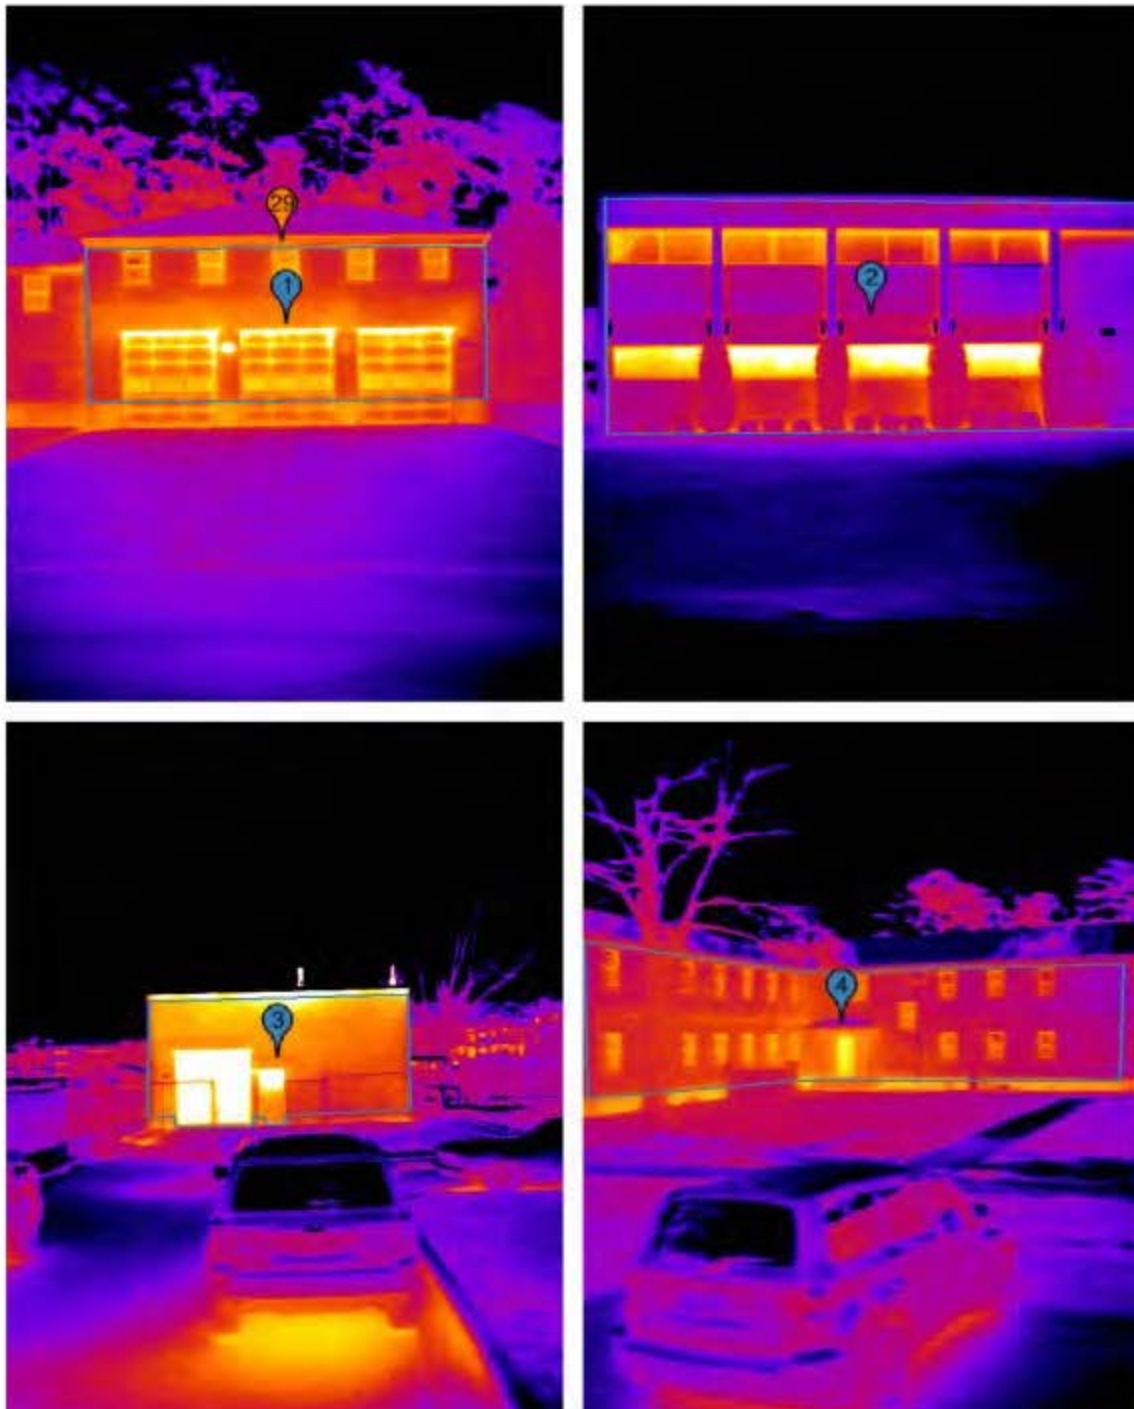
Figure 5-10. Camp Lejeune Bldgs 2600 (upper left), 895 (upper right), HP210 (lower left) and 8 (lower right).

These 30 measures would collectively save an estimated \$11,904 per year at a cost of \$144,508 with a payback period of 12.1 years. Figure 5-10 to 5-17 show the specific location of all 30 immediately actionable recommendations. Note that only the primary features (e.g., the brick walls) are analyzed in the images. Obstructions like trees or flagpoles as well as unrelated features like garage doors or windows are excluded.

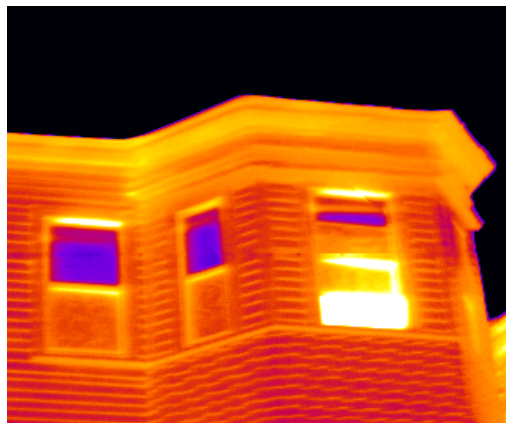
Window frames and window glass were differentiated in the 131 buildings on the base that were analyzed in detail to separate out energy loss due to conduction (e.g., poorly insulated single pane windows) and convection (leaks through cracks around window frames, e.g., Figure C-1). The system tagged 1,037 discrete window frames. The measure of leakage is expressed in cubic feet per minute per linear foot of crack. Figure C-2 shows the distribution of estimated leakages across the base.

Figure C-1. Examples of window frame leaks, Camp Lejeune.

- *Seal Window Frame Leaks.* This involves using caulk or weather-stripping to seal cracks in window frames that are letting air in or out of the building.

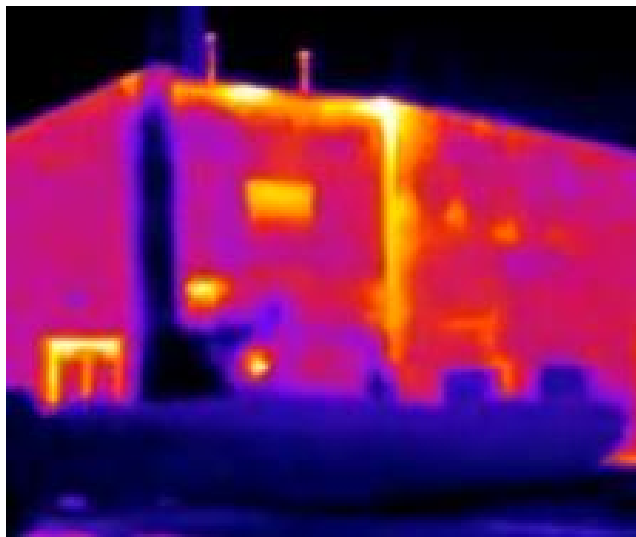
Walls on the base were categorized as either brick, siding or concrete. The system identified 315 distinct brick wall polygons, 84 siding walls, and 13 concrete walls. Costs associated with wall polygons were estimated based on their time-normalized surface temperatures (Figure C-7) and inferred R-values, as described in Section 4.2 (“Baseline Characterization”). Estimated annual combined heating and cooling costs from wall polygons range from \$1.40/sq ft to \$3.70/sq ft (Figure C-8). Brick walls in general had lower estimated costs per square foot (~\$1.90) than did siding or concrete walls (~\$2.70).

Figure C-7. Example of thermal energy losses in walls, Camp Lejeune.

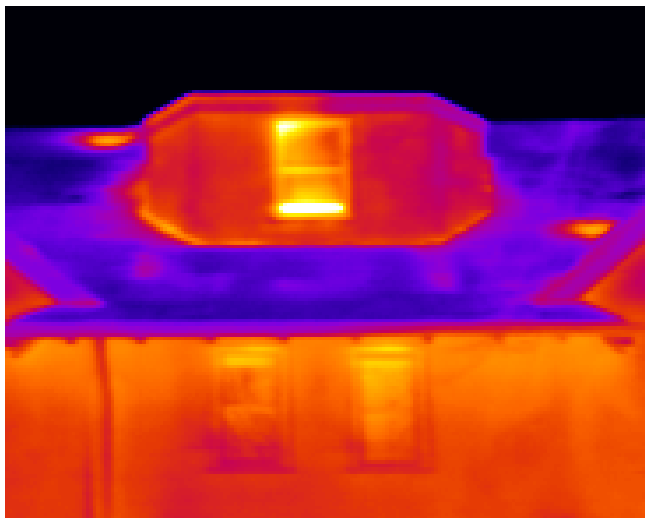
Roof heat loss is calculated similarly to wall heat loss, by looking at time-normalized surface temperatures (Figure C-10). The system identified 232 distinct roof polygons. (Note that a single roof will usually have more than one polygon identified, as the maximum size of a polygon is dictated by the FOV of the camera in a single image frame.) The estimated heating and cooling cost associated with these roofs ranged from \$1.10 to \$2.20/sq ft. A distribution of annual energy loss costs per square foot of roof area (Figure C-11).

Figure C-10. Example of thermal energy losses in roofs, Camp Lejeune.

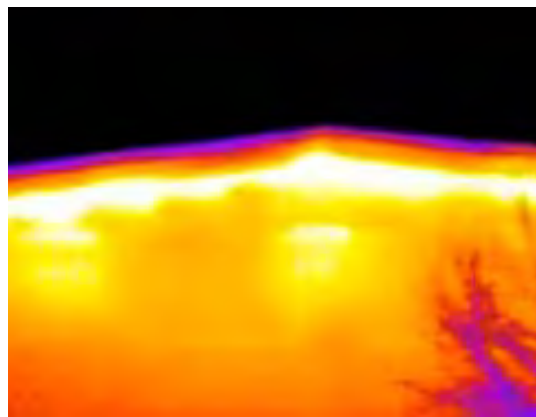
Soffits are areas where the wall meets the roof and are often spots where insulation is poor and air leaks are more common. The system identified 329 total soffit polygons on buildings in the base. Their R-values were estimated based on surface temperatures (Figure C-13) similar to the calculation for walls and roofs. The average annual heating and cooling costs for soffits range from \$1.40 to \$2.80/sq ft (Figure C-14).

Figure C-13. Example of a leaky soffit, Camp Lejeune.

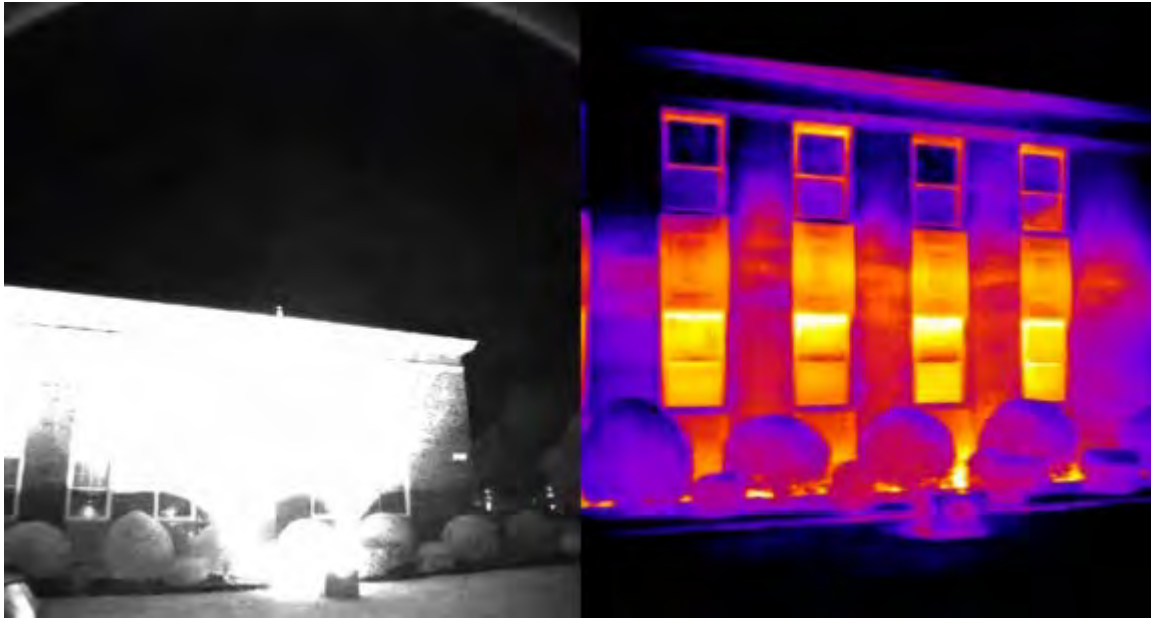
The brick wall at timestamp 323:17 in the online drive-by application is highly emissive (Figure D-3). There are some insulation holes around the middle of the wall, and the overall surface appears poorly insulated compared to other walls on the base.

Figure D-3. NIR image (left) and thermal image (right) of Bldg 1, Camp Lejeune.

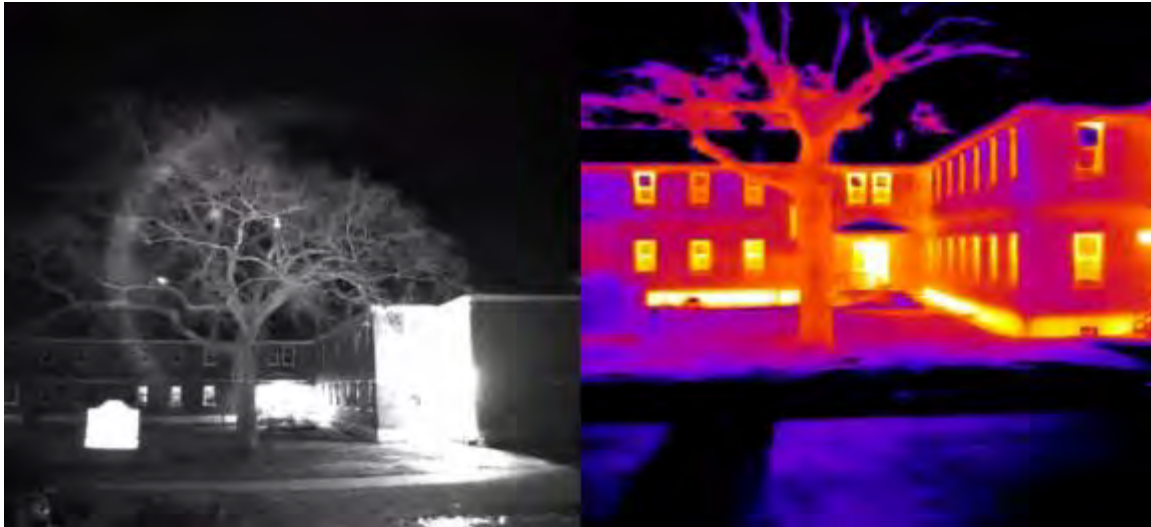
The wall of Bldg 8 at timestamp 319:57 is highly emissive relative to other buildings on the base (Figure D-8). The exposed foundation wall is also poorly insulated, allowing heat to escape from the surface. The window frames on the left side of the building are highly emissive.

Figure D-8. NIR image (left) and thermal image (right) of Bldg 8, Camp Lejeune.

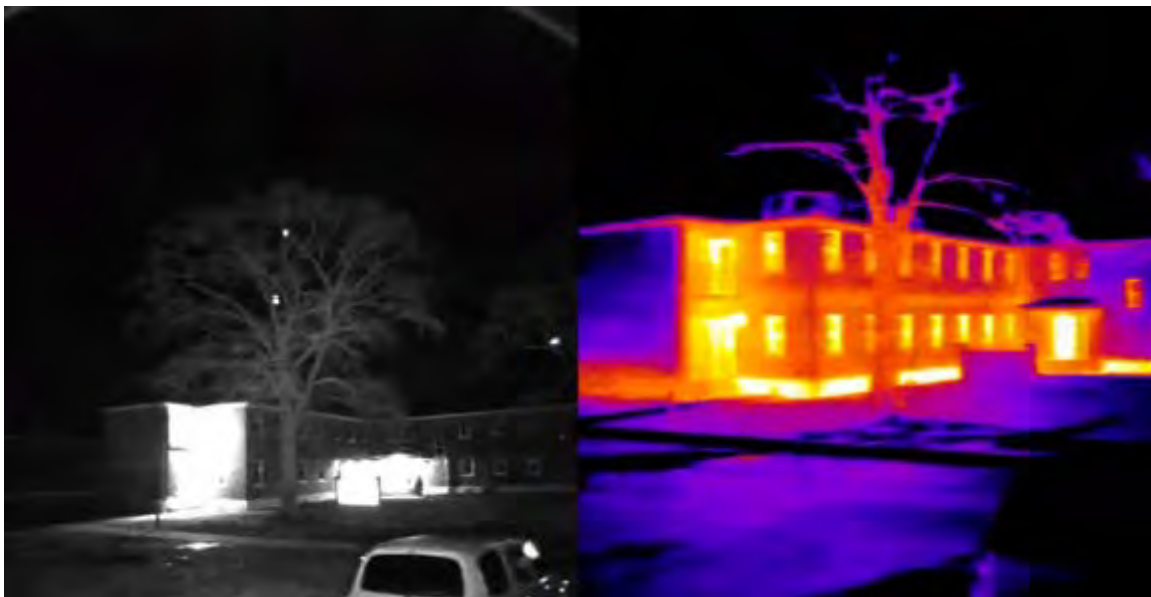
The wall at timestamp 319:58 is quite emissive, with a notable thermal bridge around the middle of the wall (Figure D-9).

Figure D-9. NIR image (left) and thermal image (right) of Bldg 8, Camp Lejeune. Note the thermal bridge around the middle of the wall.

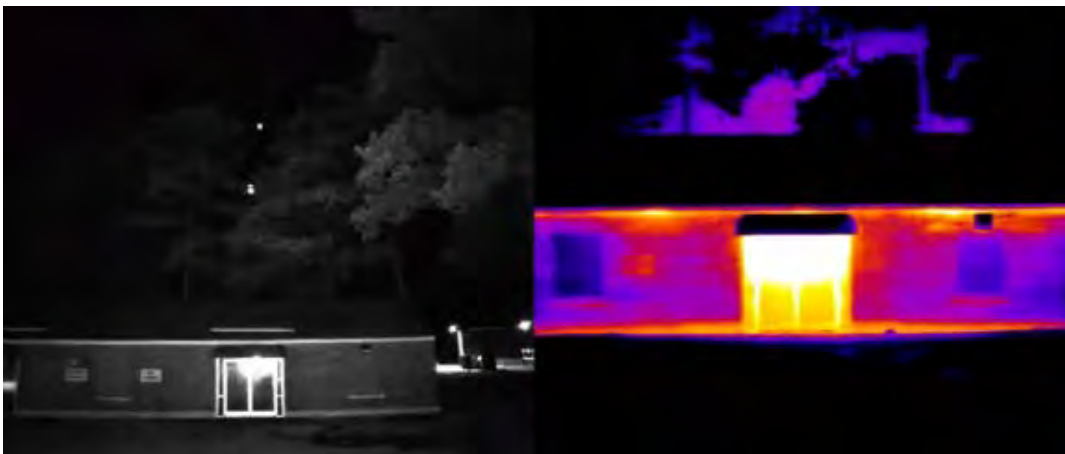
The soffit at timestamp 322:04 and the door frame are highly emissive, which potentially indicates poor insulation or convective leaks (Figure D-13). There are two notable hot spots to the left and right of the door.

Figure D-13. NIR image (left) and thermal image (right) of Bldg 11, Camp Lejeune.

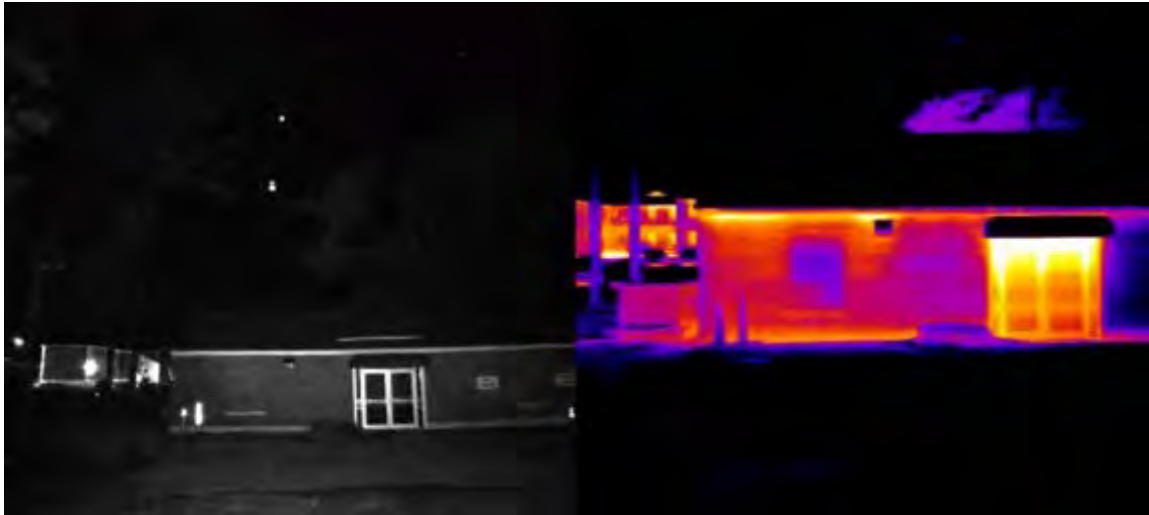
The wall to the left of the door at timestamp 322:07 has a number of emissive hot spots, as well as an emissive soffit (Figure D-14).

Figure D-14. NIR image (left) and thermal image (right) of Bldg 11, Camp Lejeune. The wall to the left of the door has a number of emissive hot spots, as well as an emissive soffit.

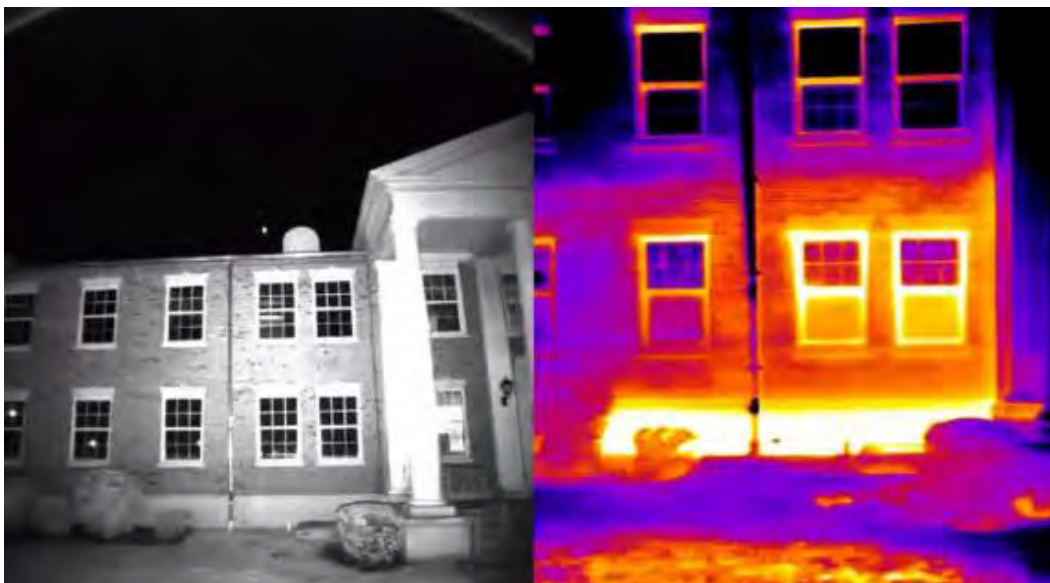
The wall and exposed foundation of Bldg 15 at timestamp 324:17 are quite emissive, which indicates poor insulation (Figure D-18). The two window frames in the bottom right corner are notably hot, and may have high convective air leakage.

Figure D-18. NIR image (left) and thermal image (right) of Bldg 15, Camp Lejeune.

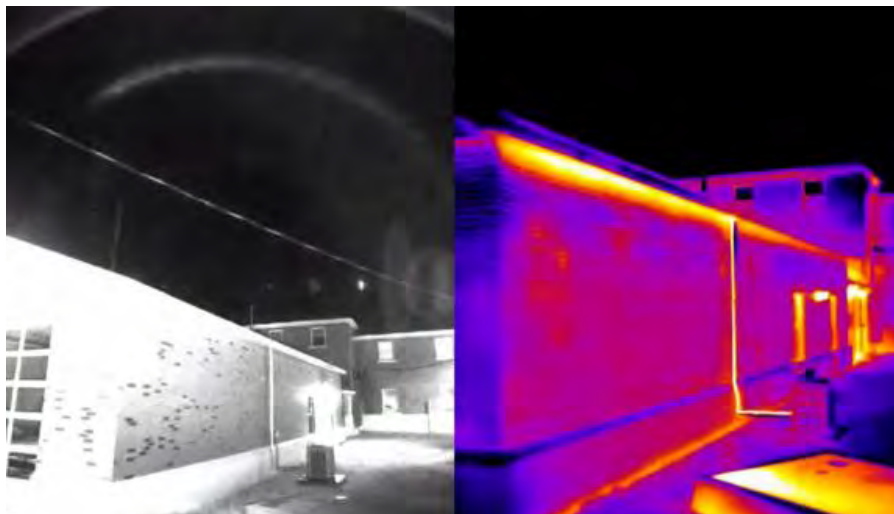
Figure D-22. NIR image (left) and thermal image (right) of Bldg 18, Camp Lejeune.

The soffit on Bldg 18 at timestamp 91:18 is highly emissive. There is also a small hot spot on the wall on the left side of the image (Figure D-22).

ECM Name	kWh Saved	Therms Saved	Dollars Saved	Upfront Cost	Payback Period
Improve Wall Insulation	740	724	468	8456	18.0
Basement Wall Insulation	427	418	271	2801	10.4
Seal Window Frame Leaks	216	211	137	713	5.2
Seal Door Frame Leaks	52	51	33	64	1.9

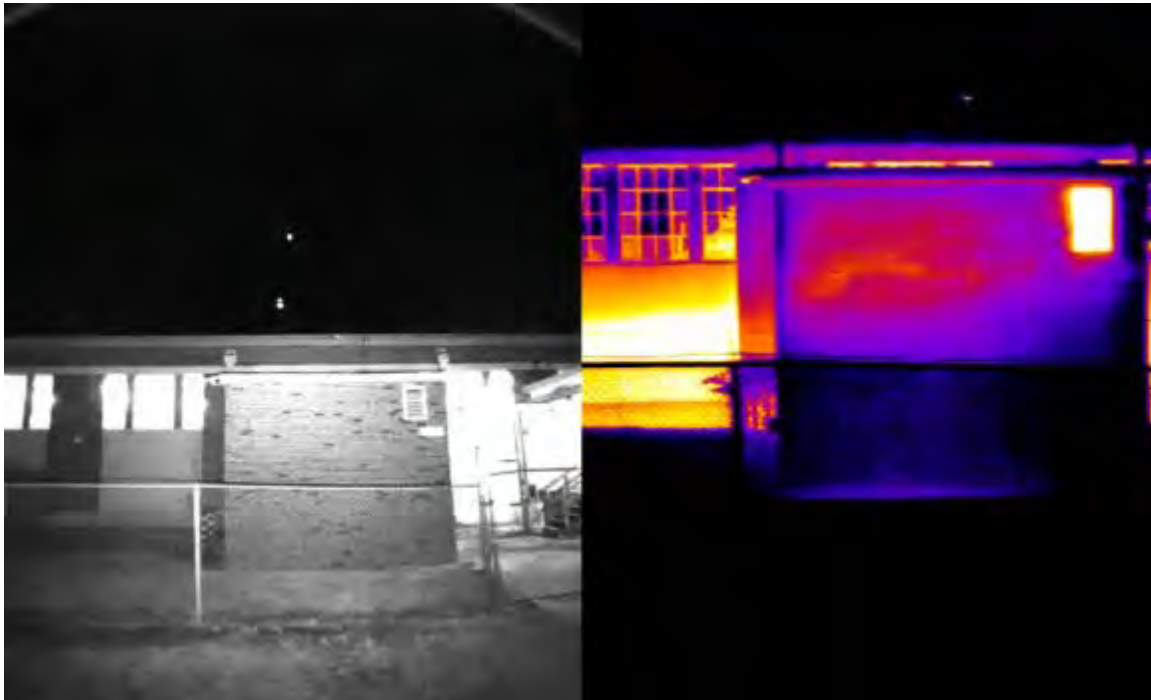
Figure D-27. NIR image (left) and thermal image (right) of Bldg 20, Camp Lejeune.

There is a hot spot on the middle of the wall of Bldg 20 at timestamp 313:13 that may indicate a hole in the wall insulation (Figure D-27).

ECM Name	kWh Saved	Therms Saved	Dollars Saved	Upfront Cost	Payback Period
Improve Wall Insulation	916	897	581	7958	13.7
Seal Window Frame Leaks	516	506	327	517	1.6

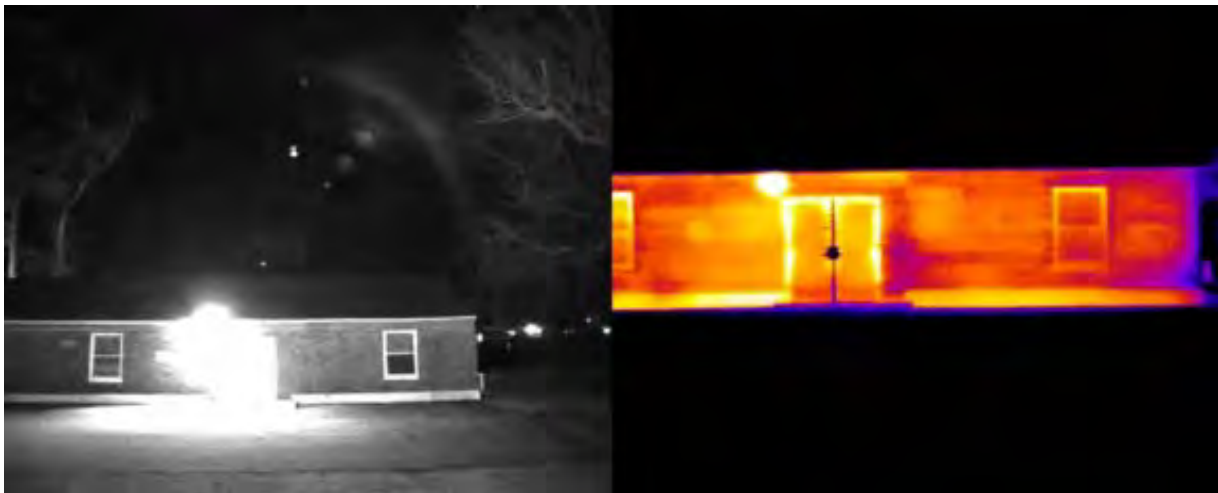
Figure D-32. NIR image (left) and thermal image (right) of Bldg 26, Camp Lejeune.

The wall of Bldg 26 visible at timestamp 321:34 had particularly poor insulation, with large notable hotspots (Figure D-32). The door in the center has large leaks in the frame that could potentially be mitigated through air sealing.

ECM Name	kWh Saved	Therms Saved	Dollars Saved	Upfront Cost	Payback Period
Improve Wall Insulation	379	371	240	2837	11.8
Seal Window Frame Leaks	90	88	57	259	4.5
Seal Door Frame Leaks	69	68	44	129	2.9
Basement Wall Insulation	61	59	38	388	10.1
Improve Soffit Insulation	17	17	11	154	14.4

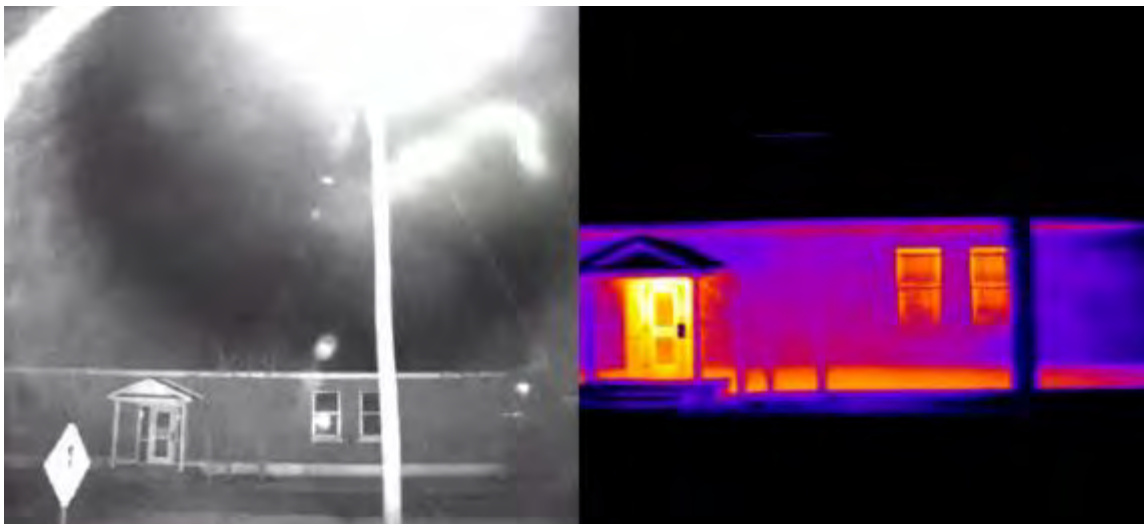
Figure D-36. NIR image (left) and thermal image (right) of Bldg 37, Camp Lejeune.

The exposed foundation of Bldg 37 at timestamp 133:58 is highly emissive (Figure D-36). The window frames are also much warmer than typical window frames on Lejeune buildings, which indicates convective leakage.

ECM Name	kWh Saved	Therms Saved	Dollars Saved	Upfront Cost	Payback Period
Seal Window Frame Leaks	268	262	170	972	5.7
Basement Wall Insulation	53	51	33	828	24.9
Seal Door Frame Leaks	51	50	32	128	4.0

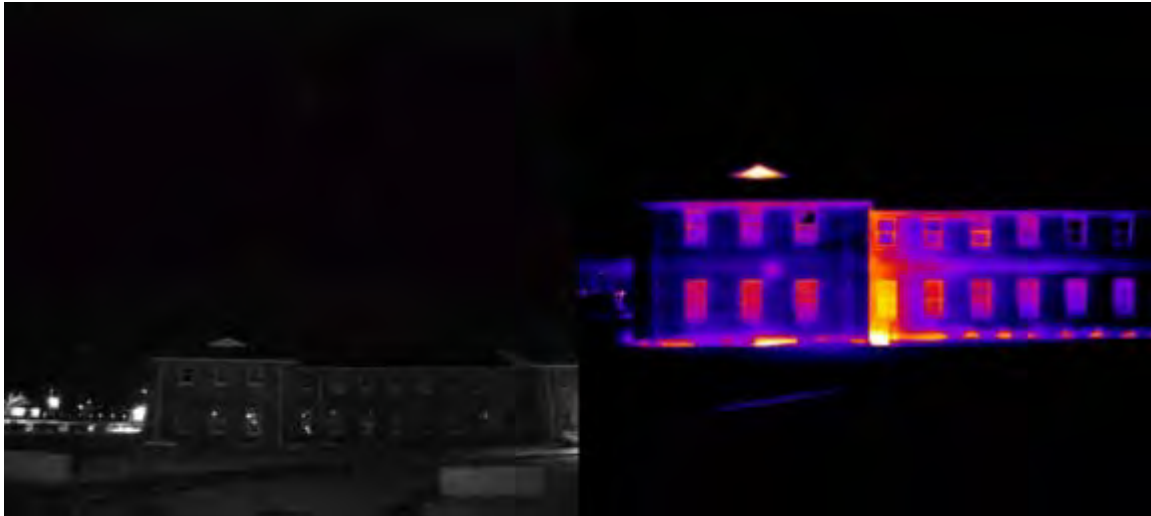
Figure D-40. NIR image (left) and thermal image (right) of Bldg 58, Camp Lejeune.

Bldg 58 has a thermal bridge noticeable near the middle of the wall on the right side at timestamp 134:44 (Figure D-40). There is also a hot spot on the wall on the left side of the image.

ECM Name	kWh Saved	Therms Saved	Dollars Saved	Upfront Cost	Payback Period
Seal Window Frame Leaks	344	337	218	2392	11.0
Seal Door Frame Leaks	66	65	42	64	1.5
Improve Roof Insulation	19	18	12	136	11.6

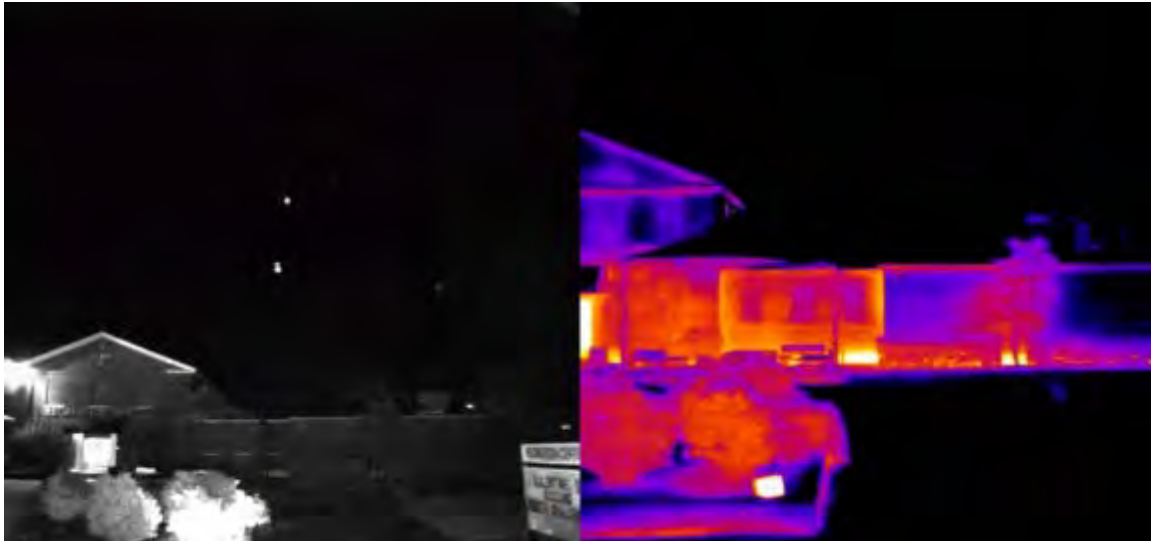
Figure D-45. NIR image (left) and thermal image (right) of Bldg 62, Camp Lejeune.

The walls of Bldg 62 at timestamp 325:33 are poorly insulated (Figure D-45).

ECM Name	kWh Saved	Therms Saved	Dollars Saved	Upfront Cost	Payback Period
Improve Wall Insulation	903	884	572	11474	20.0
Seal Window Frame Leaks	127	124	80	841	10.5
Improve Soffit Insulation	46	45	29	543	18.5
Seal Door Frame Leaks	29	28	18	64	3.5
Improve Roof Insulation	27	27	17	261	15.1

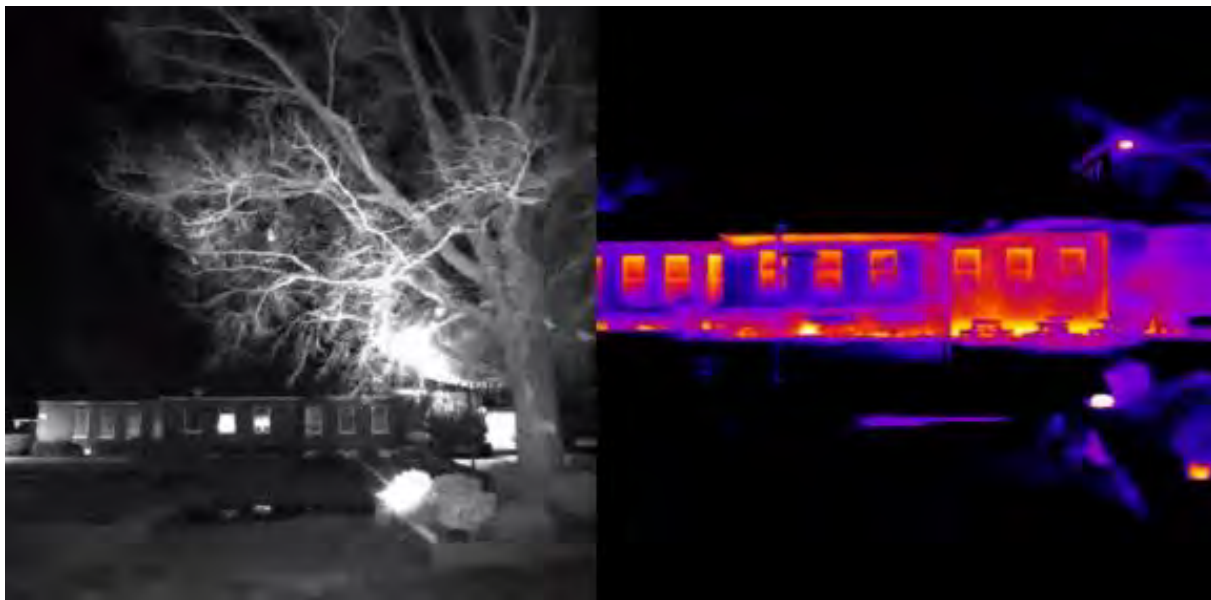
The soffit at timestamp 325:36 is emissive, as are the window frames visible in the image (Figure D-46).

Figure D-46. NIR image (left) and thermal image (right) of Bldg 62, Camp Lejeune. The soffit and window frames appear to be highly emissive.

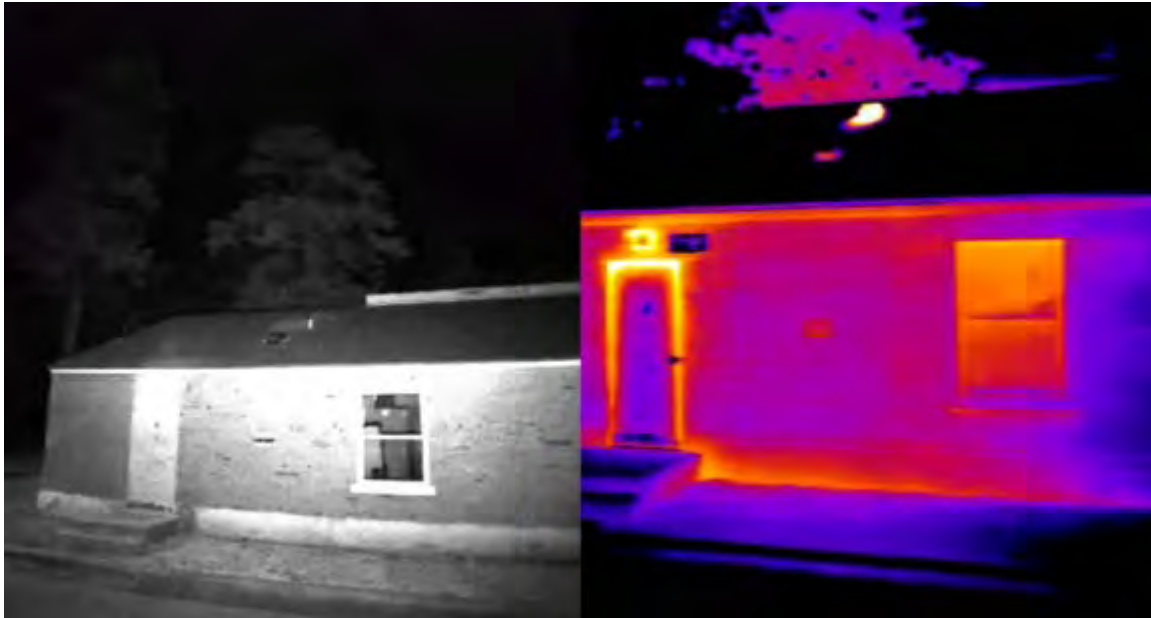
Figure D-50. NIR image (left) and thermal image (right) of Bldg 116, Camp Lejeune.

The wall of Bldg 116 is fairly emissive compared to most buildings on the base (Figure D-50). The door frame at timestamp 87:26 is also noticeably leaky.

ECM Name	kWh Saved	Therms Saved	Dollars Saved	Upfront Cost	Payback Period
Seal Window Frame Leaks	285	279	181	516	2.9
Improve Wall Insulation	209	205	133	2345	17.7
Seal Door Frame Leaks	52	51	33	193	5.9

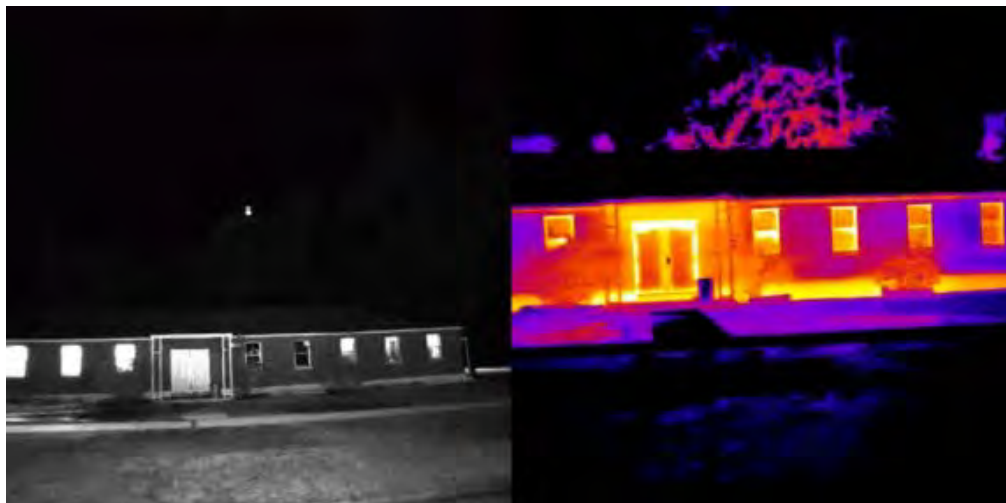
Figure D-55. NIR image (left) and thermal image (right) of Bldg 117, Camp Lejeune.

The wall of Bldg 117 at timestamp 290:20 (Figure D-55) is more emissive than the walls of most other buildings on the base. The soffits and window frames are also fairly emissive.

ECM Name	kWh Saved	Therms Saved	Dollars Saved	Upfront Cost	Payback Period
Improve Wall Insulation	717	702	454	6878	15.1
Seal Window Frame Leaks	153	150	97	712	7.3
Basement Wall Insulation	111	109	70	1666	23.7
Improve Soffit Insulation	75	73	48	823	17.3

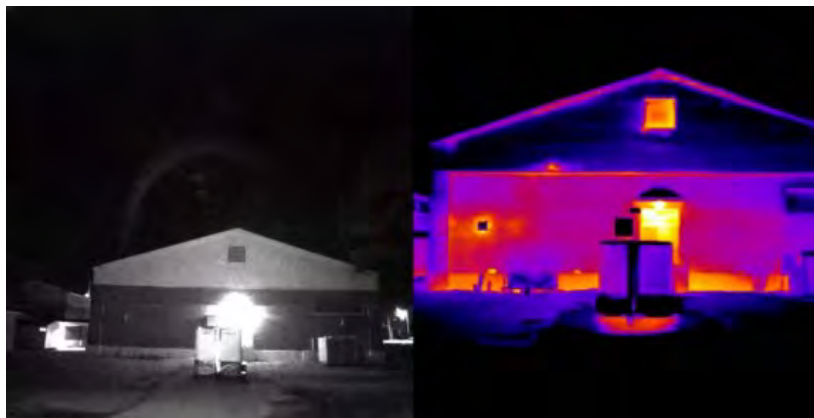
Figure D-59. NIR image (left) and thermal image (right) of Bldg 201, Camp Lejeune.

The wall and roof of Bldg 201 are notable emissive, as shown at timestamp 111:58 (Figure D-59). There is a hot spot on the left side of the wall, as well as an apparent insulation hole near the top-left of the building.

ECM Name	kWh Saved	Therms Saved	Dollars Saved	Upfront Cost	Payback Period
Seal Window Frame Leaks	92	90	58	64	1.1
Seal Door Frame Leaks	48	47	30	64	2.1
Improve Soffit Insulation	39	38	24	483	19.8
Basement Wall Insulation	30	29	19	362	19.0

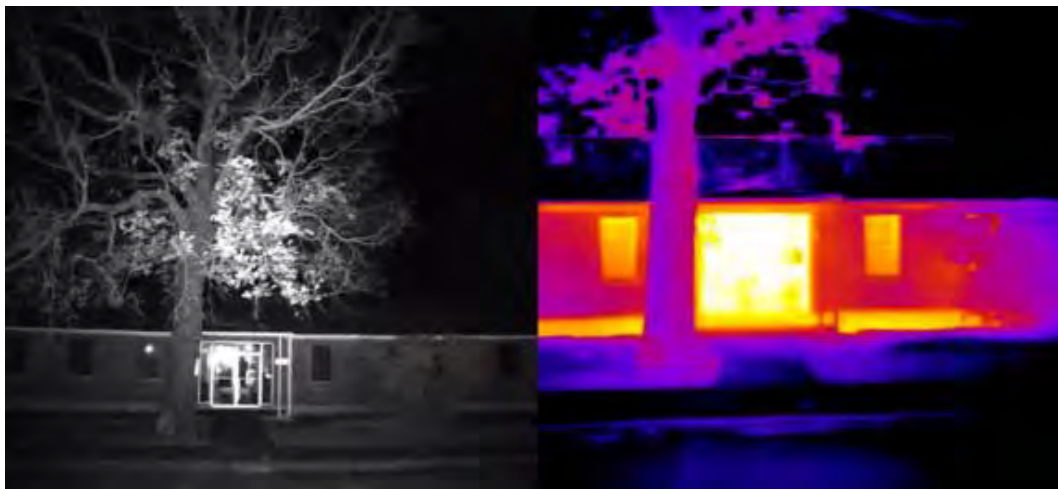
Figure D-63. NIR image (left) and thermal image (right) of Bldg 203, Camp Lejeune.

The wall and exposed foundation of Bldg 203 as shown at timestamp 108:33 are both quite emissive and poorly insulated (Figure D-63). The windows and door frame are also more emissive than most.

ECM Name	kWh Saved	Therms Saved	Dollars Saved	Upfront Cost	Payback Period
Improve Wall Insulation	223	219	142	2283	16.1
Basement Wall Insulation	93	91	59	847	14.3
Seal Window Frame Leaks	61	59	38	324	8.4
Seal Door Frame Leaks	26	26	17	65	3.9

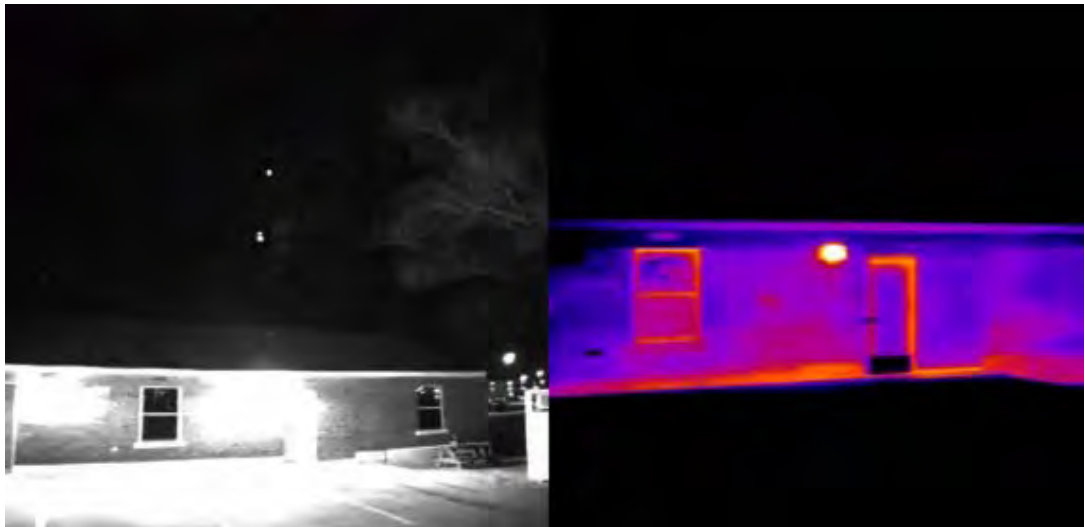
Figure D-67. NIR image (left) and thermal image (right) of Bldg 207, Camp Lejeune.

The wall of Bldg 207 at timestamp 302:44 is notable hot, with some discrete hot spots near the center of the image (Figure D-67).

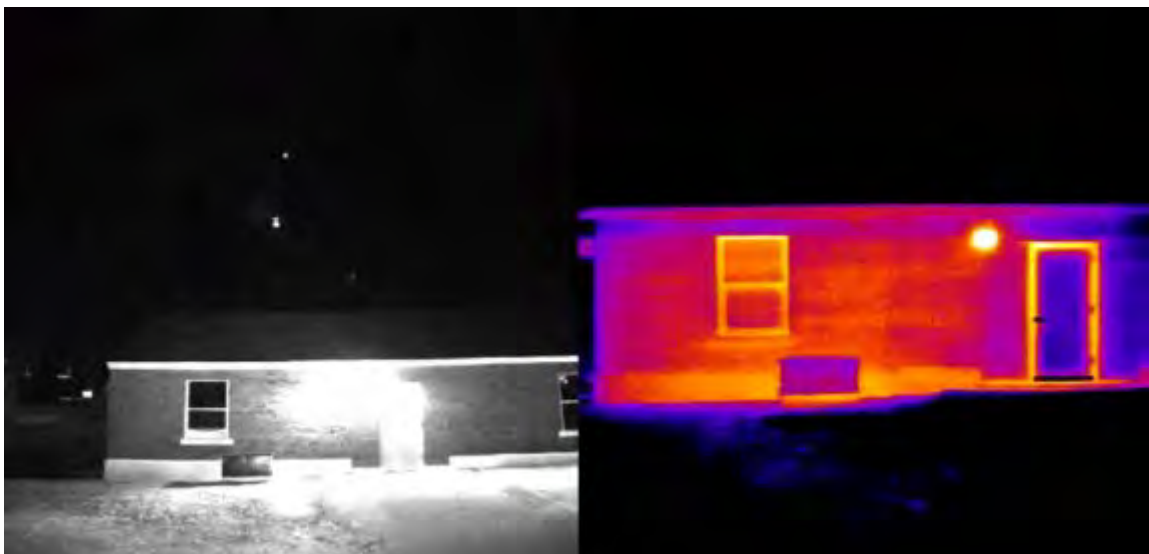
The window frame and the wall to the right of it at timestamp 302:46 are quite hot and may be effectively remediated with improved insulation and air sealing (Figure D-68).

Figure D-68. NIR image (left) and thermal image (right) of Bldg 207, Camp Lejeune. The window frame and the wall to the right of it are quite hot.

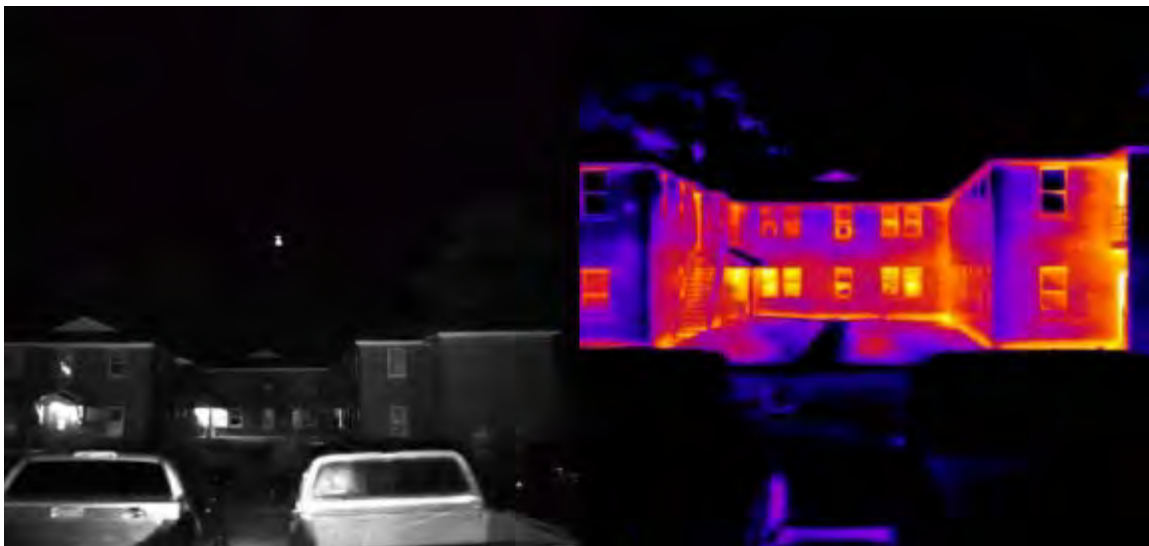
Figure D-72. NIR image (left) and thermal image (right) of Bldg 217, Camp Lejeune.

The wall of Bldg 217 at timestamp 308:58 is highly emissive, particularly in the right side of the image and in the back-right corner (Figure D-72).

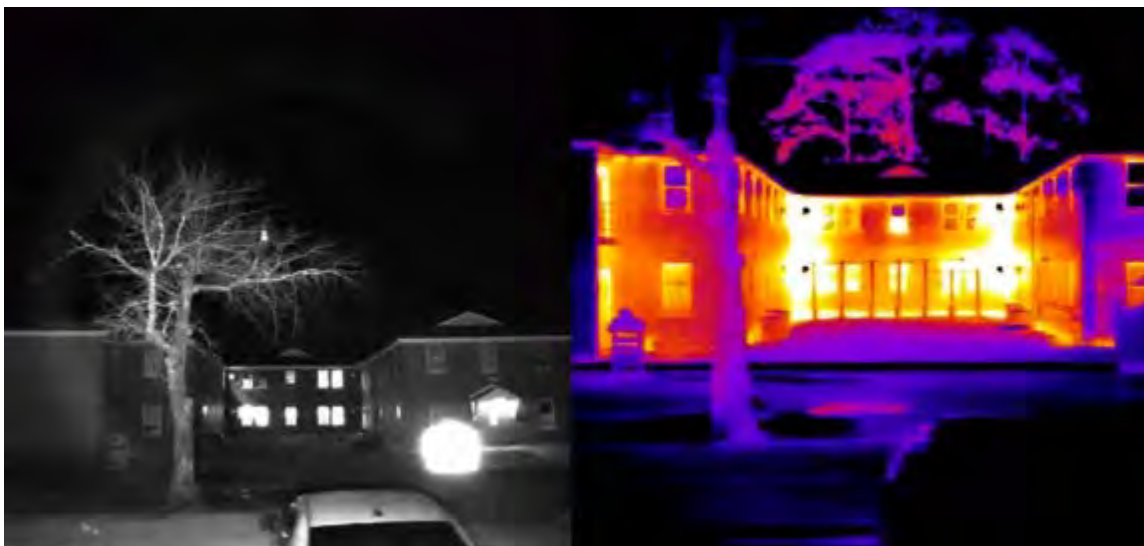
The wall in the back left and right of the image at timestamp 309:01 is very highly emissive, which likely indicates poor insulation (Figure D-73).

Figure D-73. NIR image (left) and thermal image (right) of Bldg 217, Camp Lejeune. The wall in the rear left and rear right of the image is very highly emissive.

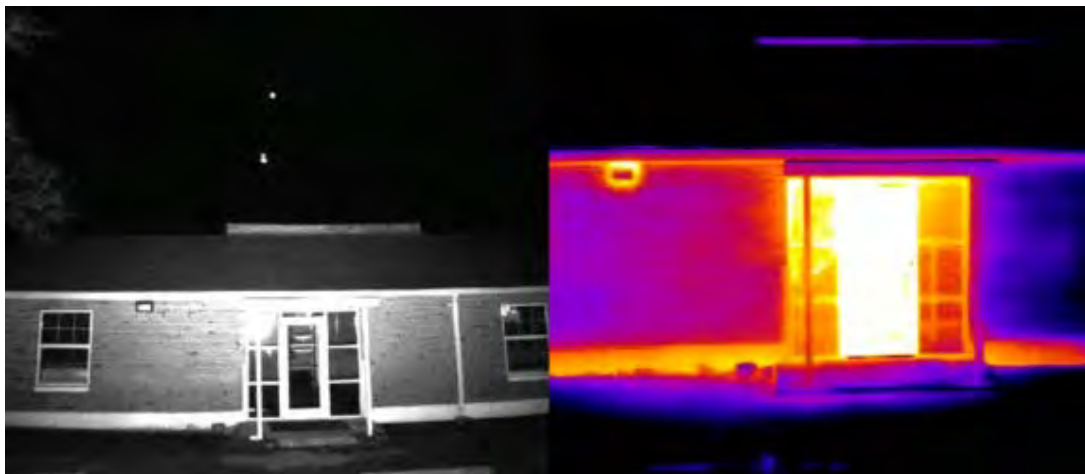
Figure D-77. NIR image (left) and thermal image (right) of Bldg 233, Camp Lejeune.

The foundation wall, door frame, and soffit at timestamp 304:06 are all highly emissive (Figure D-77).
